ELECTRIC SHOCK DROWNING: THE INVISIBLE KILLER!

Created and Presented By:
Kevin Ritz

Copyright 2019

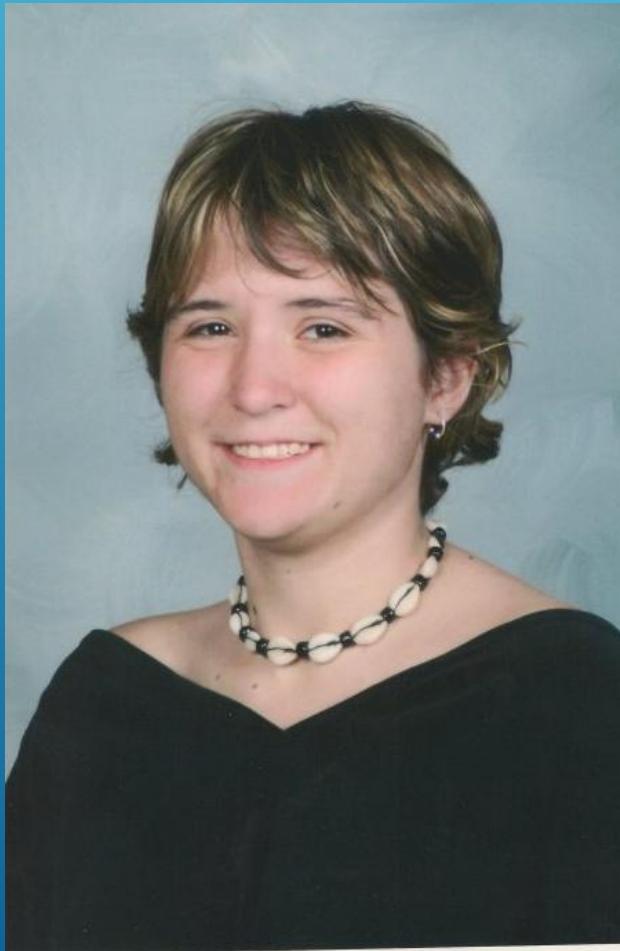
SAMANTHA CHIPLEY, 19

- ▶ Died Jun 27th 2005 At 19 Years of age.
- ▶ Scott Creek Marina, Cave Run Lake, Moorhead, KY
- ▶ Caused By Lack Of Grounding System And Faulty Battery Charger On Houseboat
- ▶ Would Be Rescuer Dived Into Water Only To Be Turned Back By Electrical Field

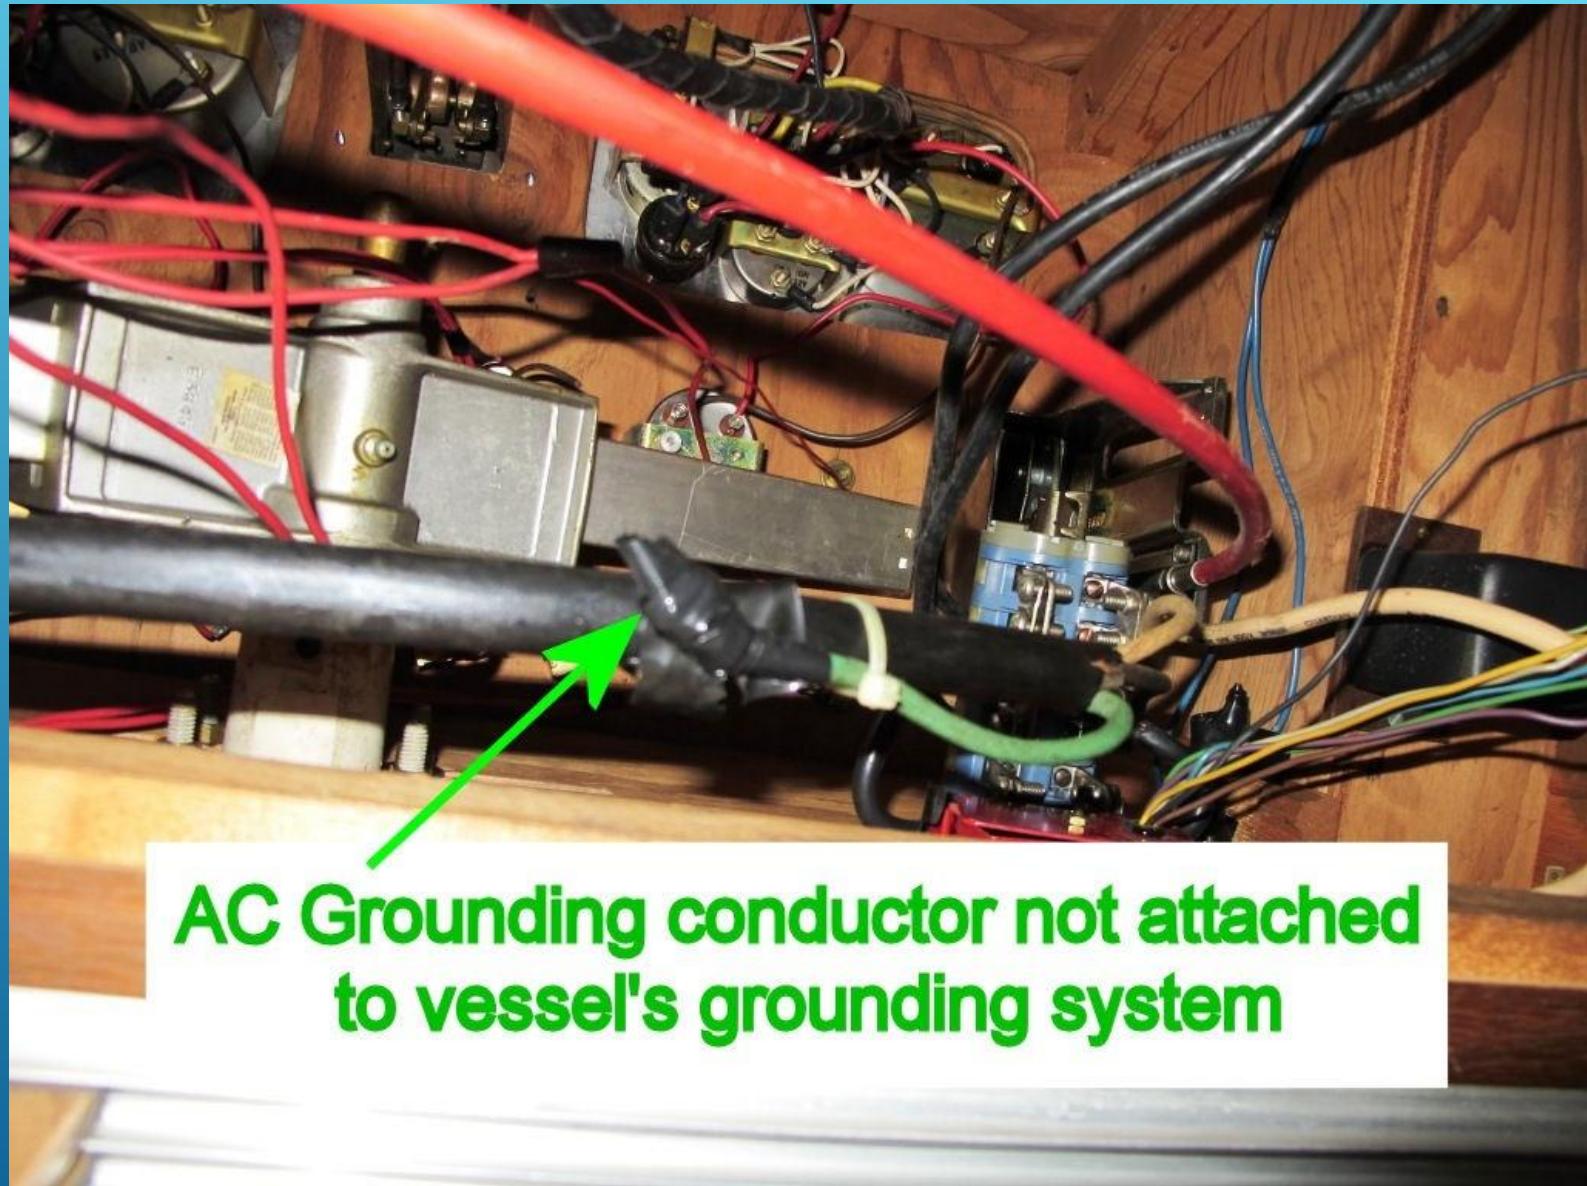
**AC Grounding conductor not attached
to vessel's grounding system**

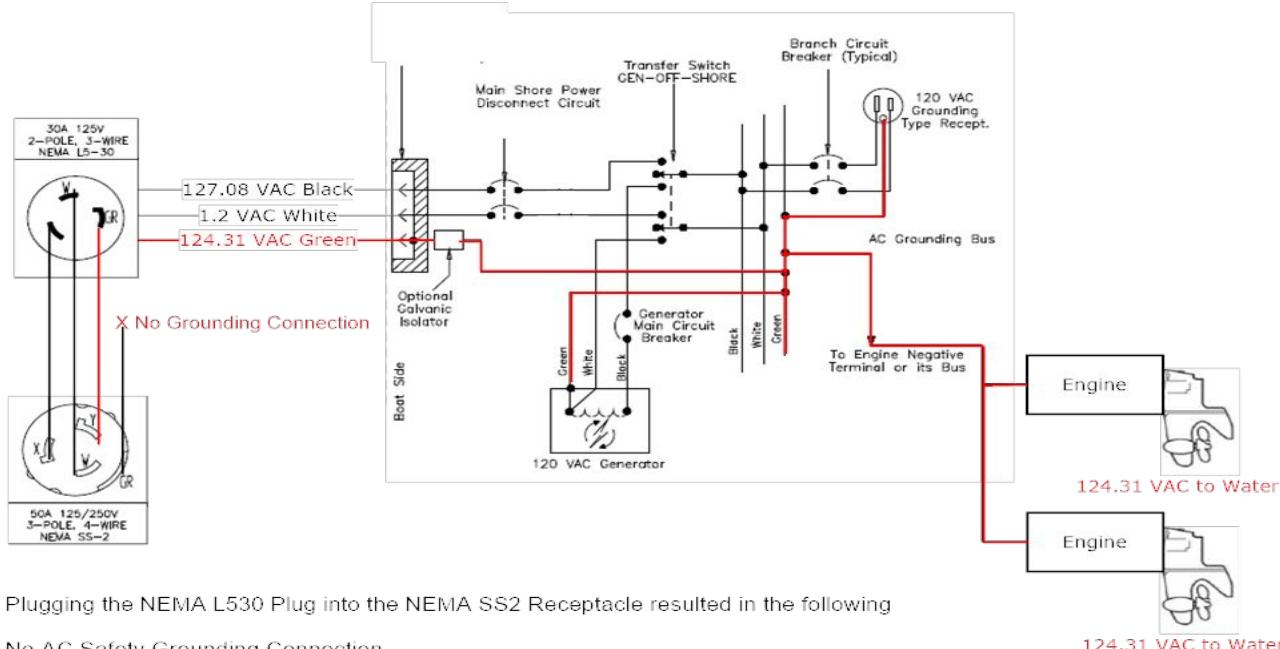
Plugging the NEMA L530 Plug into the NEMA SS2 Receptacle resulted in the following

No AC Safety Grounding Connection

Marina X Connected to Ungrounded connection on L530

Marina Y Connected to Grounding connection on L530 Putting 124.31 VAC into Water

Marina Grounding Connected to Grounding on L530

124.31 VAC to Water

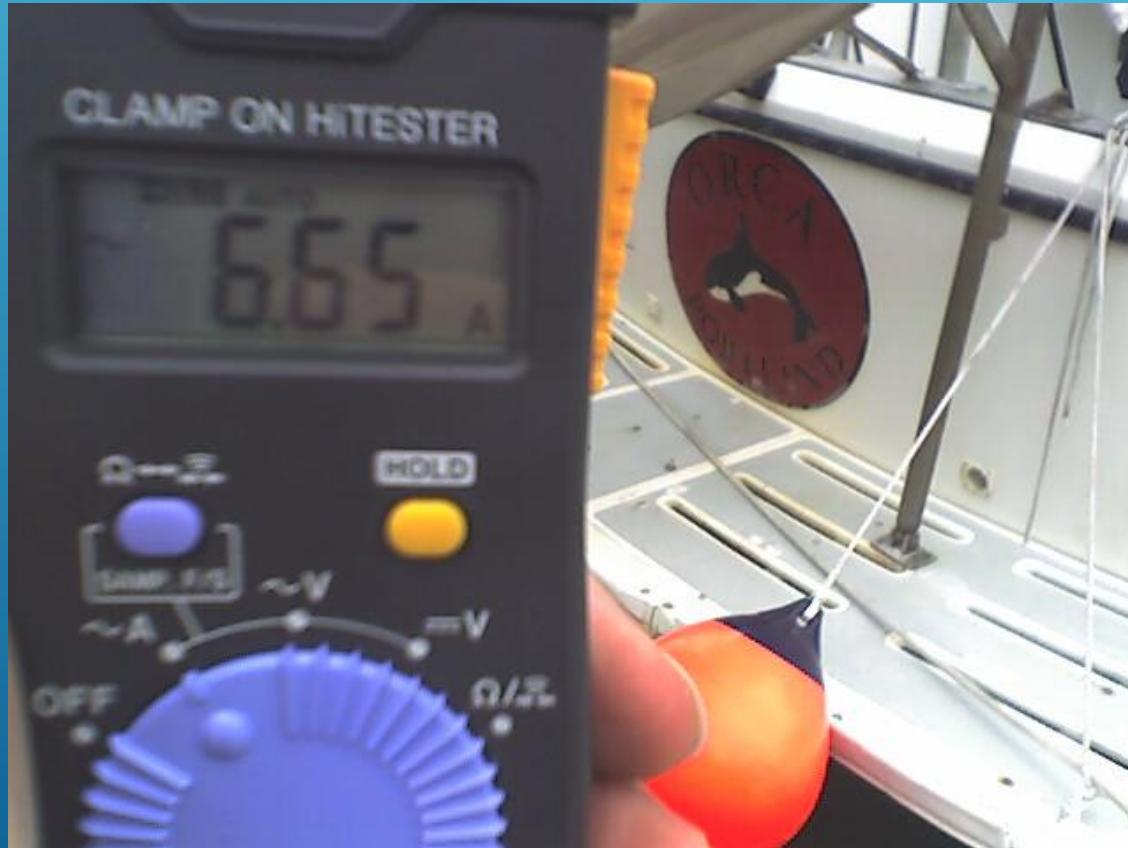
- Clamp one, and then the other
- If you get a reading, clamp both together
- If you then still get a reading, you have a leak of that magnitude
- If you are unable to clamp both for some reason, record the two readings and subtract them; the result should be zero. If it is not, you have a leak of that magnitude

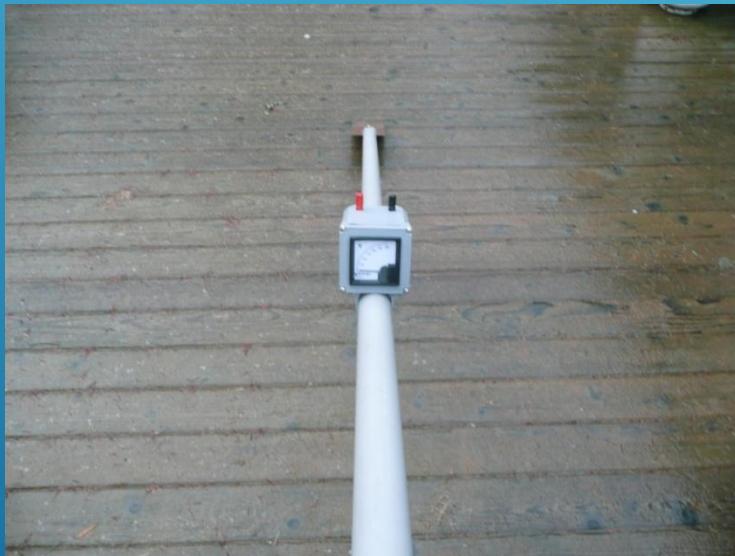
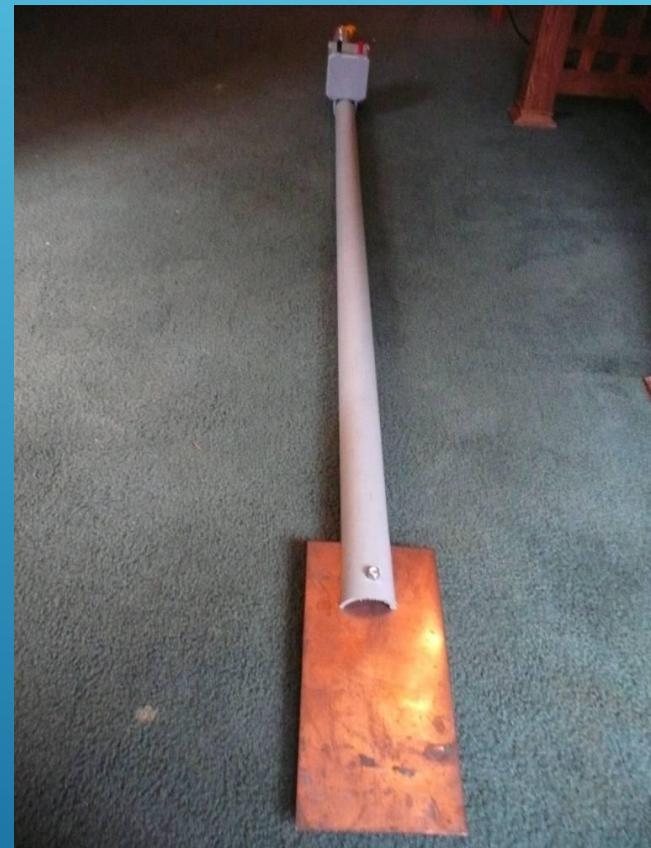
AC VOLTAGE PROBE

- ▶ The AC voltage can be easily tested and documented using a probe.
- ▶ This is accomplished by placing a meter, in line, between the water probe and the dock ground.
- ▶ Always test ground integrity.
- ▶ As the probe approaches the source, voltage will increase.
- ▶ Be sure that each AC component on-board, or on the dock, that cycles (i.e., sump pumps, battery chargers, water heaters, space heaters, etc.) cycles while the water is being probed.

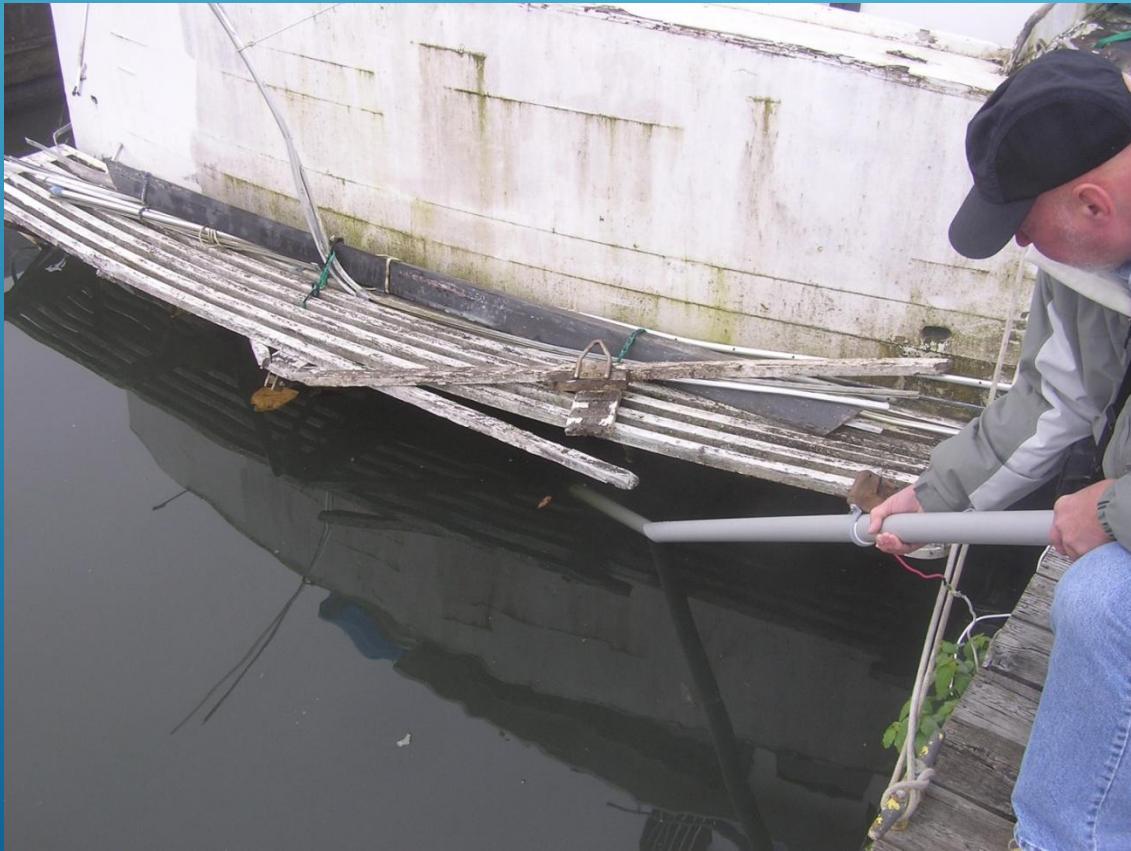
PROBING FOR VOLTAGE 89 VAC 1 FOOT FROM PROPELLER

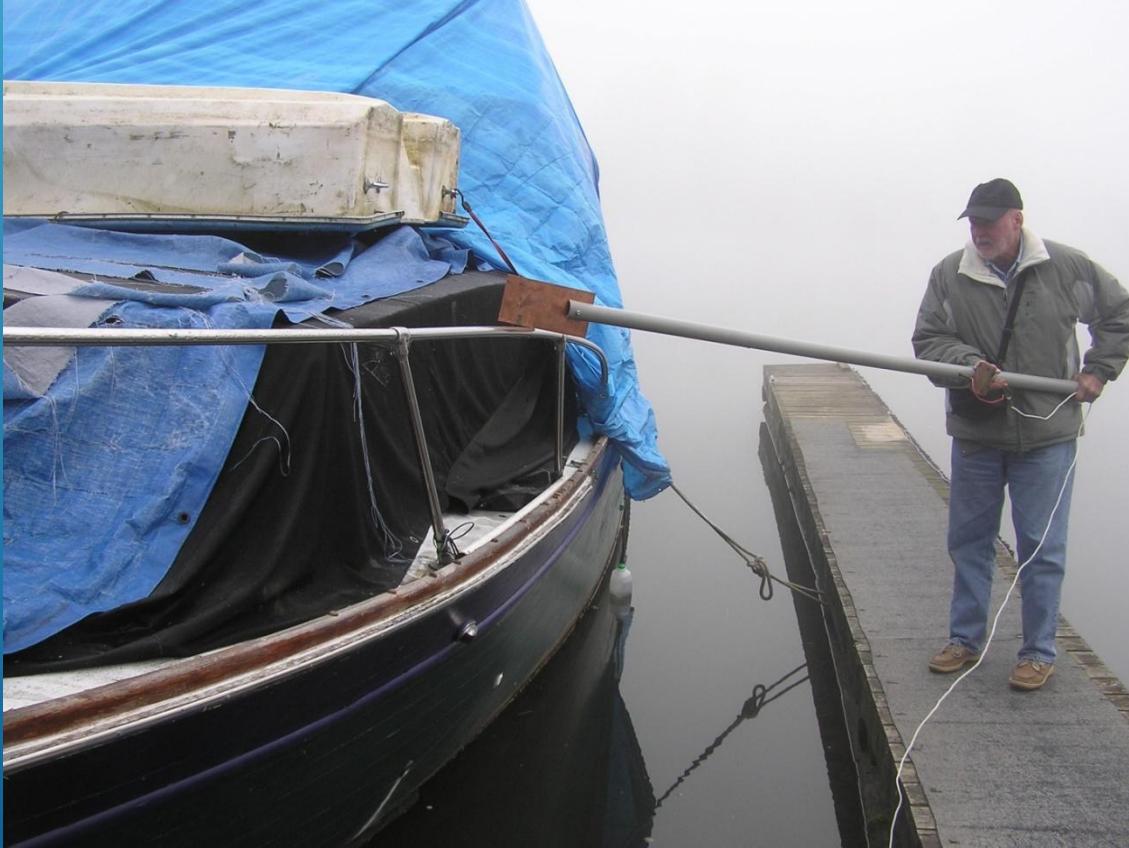
EVERYTHING IS HOT! 24 VOLTS AC ON STANCHIONS

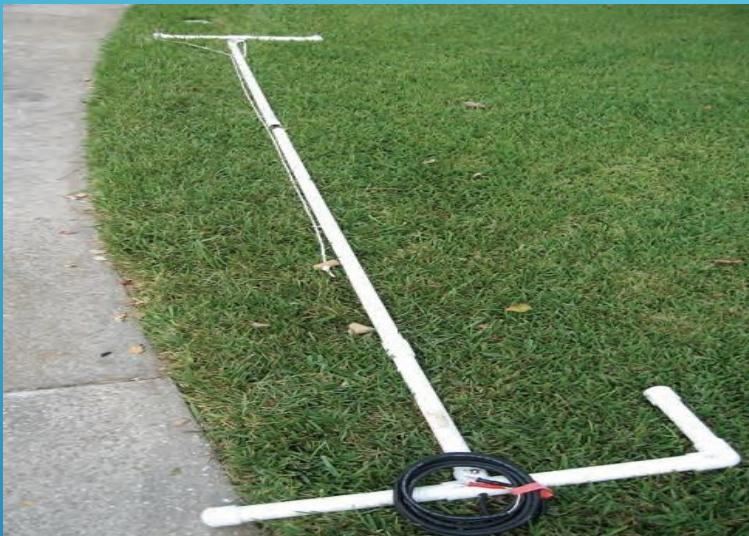
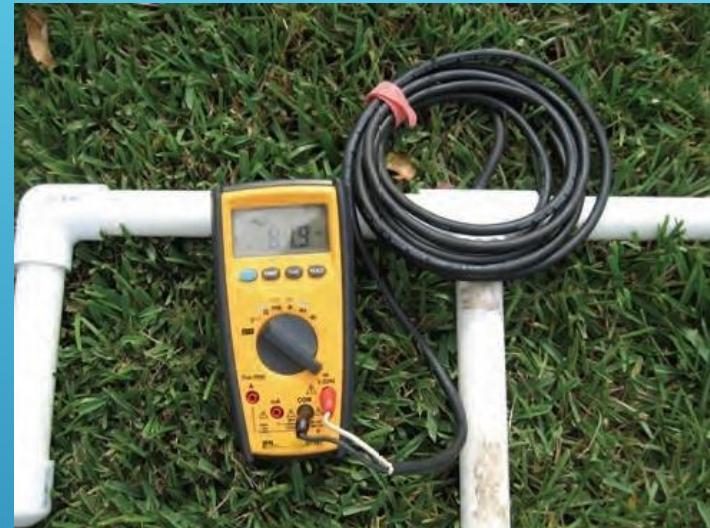
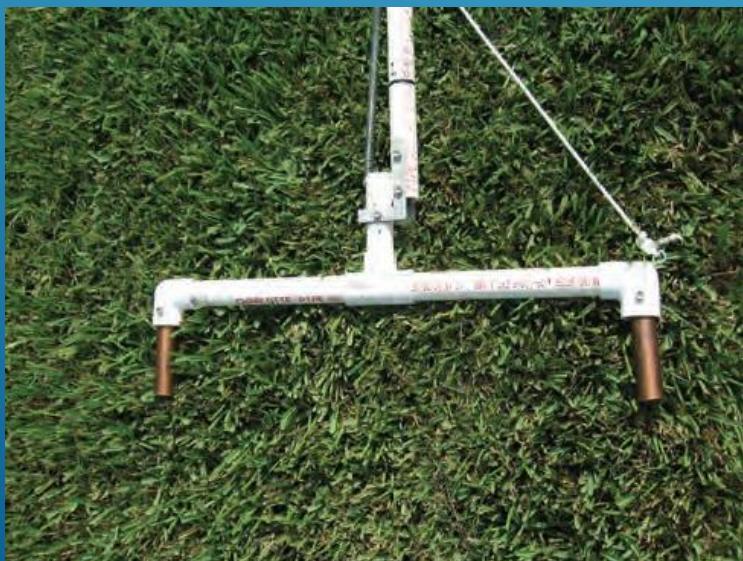
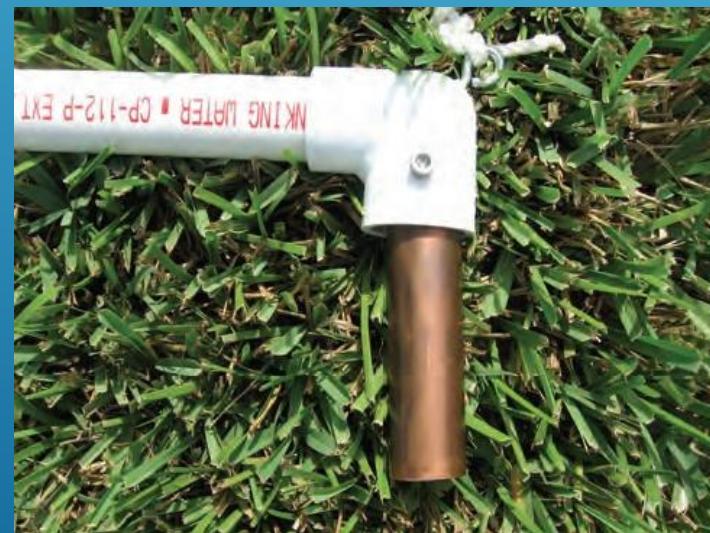
Voltage Gradient Probe

Potentially lethal voltage gradient—two volts AC per foot. This voltage (2VAC/Ft.) will push 12 millamps of AC current through the body potentially inducing muscular paralysis.
